DEPARTMENT OF NATURAL RESOURCES
DIVISION OF OIL, GAS AND MINING

RE: Site Inspection, International Uranium, Rim/Columbus Mine, M/037/006, San Juan County, Utah

Date of Inspection: August 14, 2002
Time of Inspection: About 4:20 to 6:00 p.m.
Conditions: Mostly clear, 80's
Participants: Doug Jensen and Paul Baker, DOGM

Photographs
M/037/006
Rim/Columbus Mine

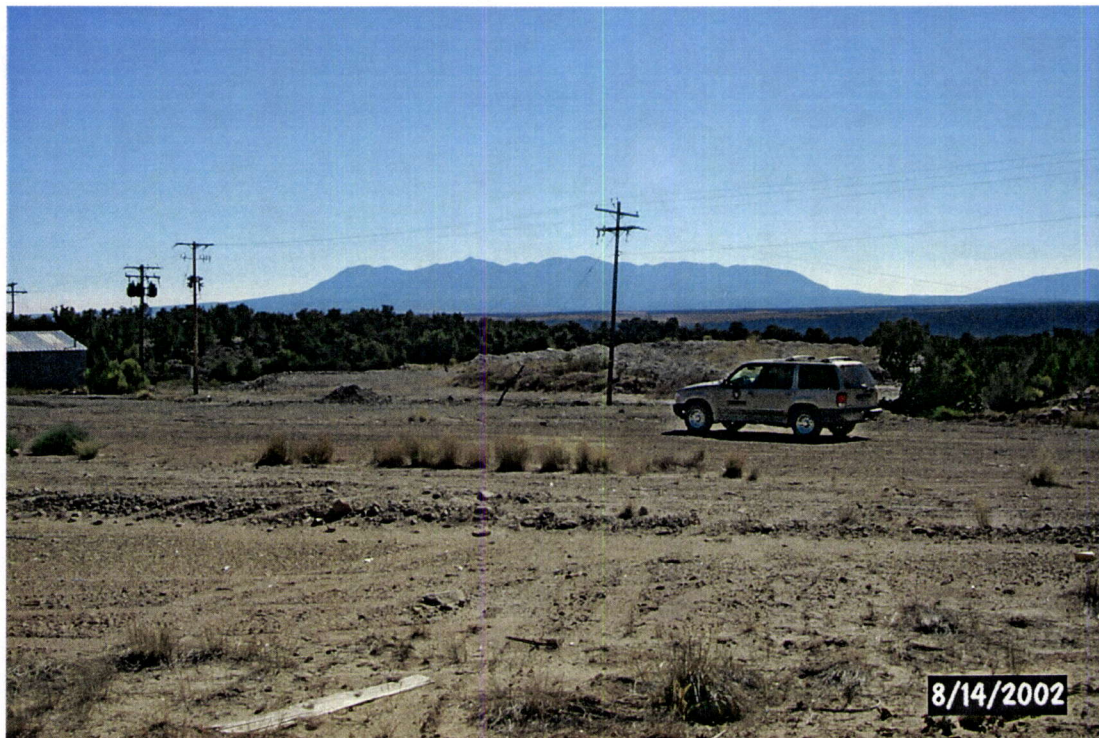
Our observations were fairly general in nature. The Rim Mine is, as the name suggests, at the edge of a plateau. Included in the facilities at the Rim Mine are a headframe, a waste pile of about one acre, power poles and transformers, some ponds, and some old buildings (see Photos 1-3). The support below the transformers was apparently broken and being held up by a pole. The operator needs to correct this problem.

Photo 1. Rim Mine with waste pile near the center just beyond the vehicle.

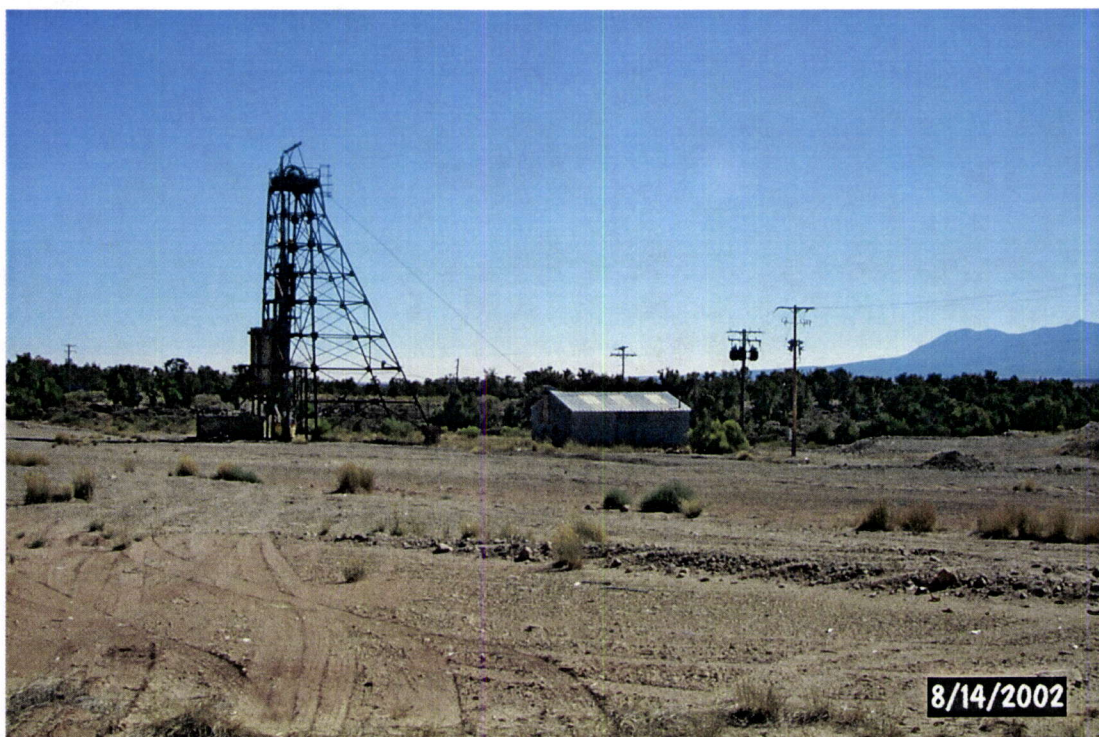
Photo 2. Headframe at the Rim Mine.

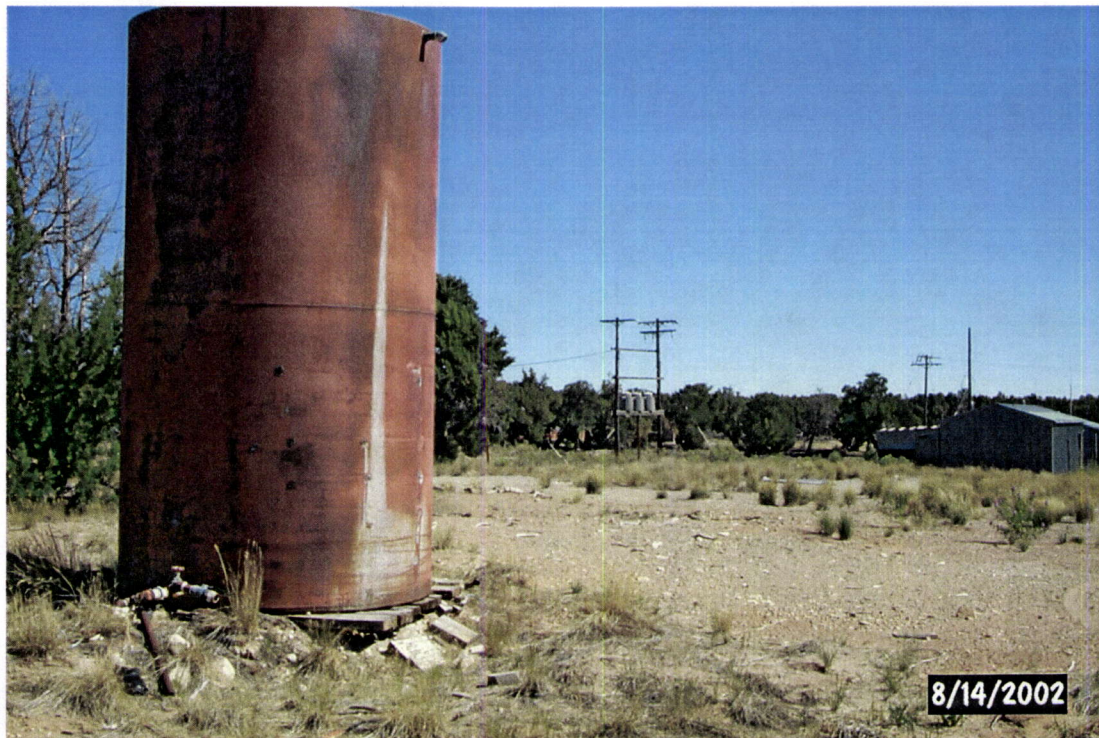
Photo 3. Some of the facilities at the Rim Mine.

Since the inspection was done, I have been told the operator has cleaned up some garbage at the Rim Mine and has removed the three transformers on the unstable support. There are still some transformers at the mine.

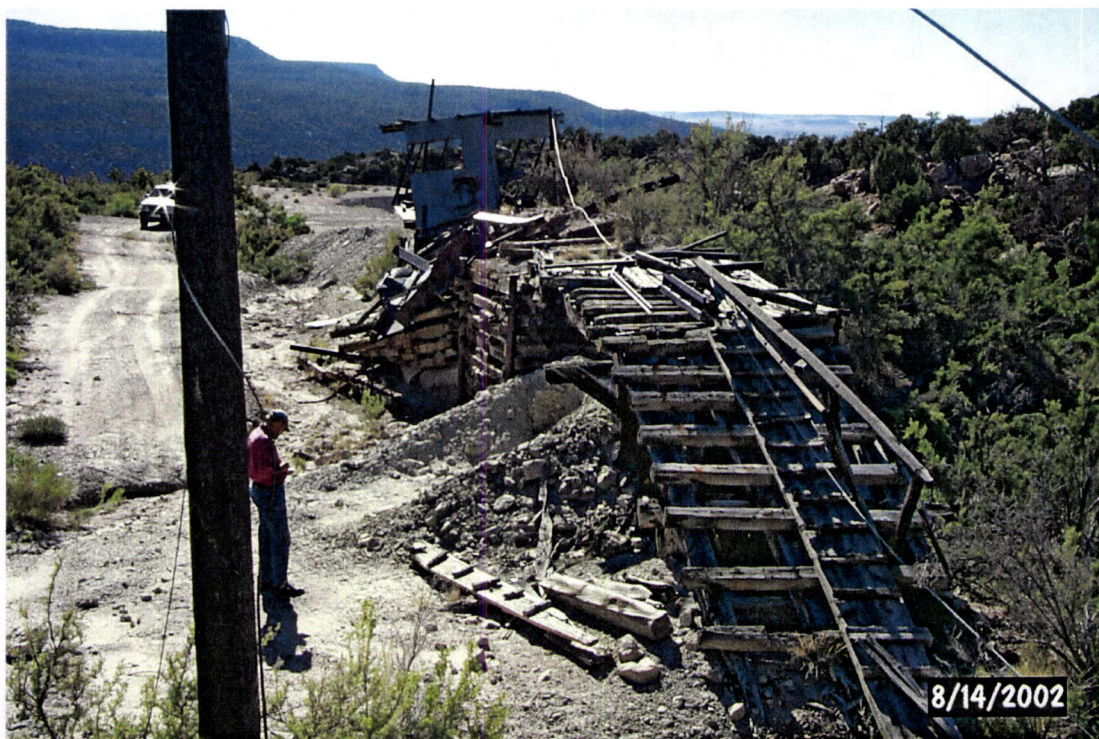
The Columbus and Humbug Mines are below the rim on the slope leading to the valley below. Going down the road, the Columbus Mine is the first one encountered. Facilities at this site consist of an old, dilapidated tibble (Photo 4), a waste pile, and an unsecured portal in a decline (photo 5). There is a lot of erosion coming off from the waste pile and getting the drainage (Photo 6). The waste pile is on top of the drainage.

Photo 4. Tippie or loadout at the Columbus Mine.

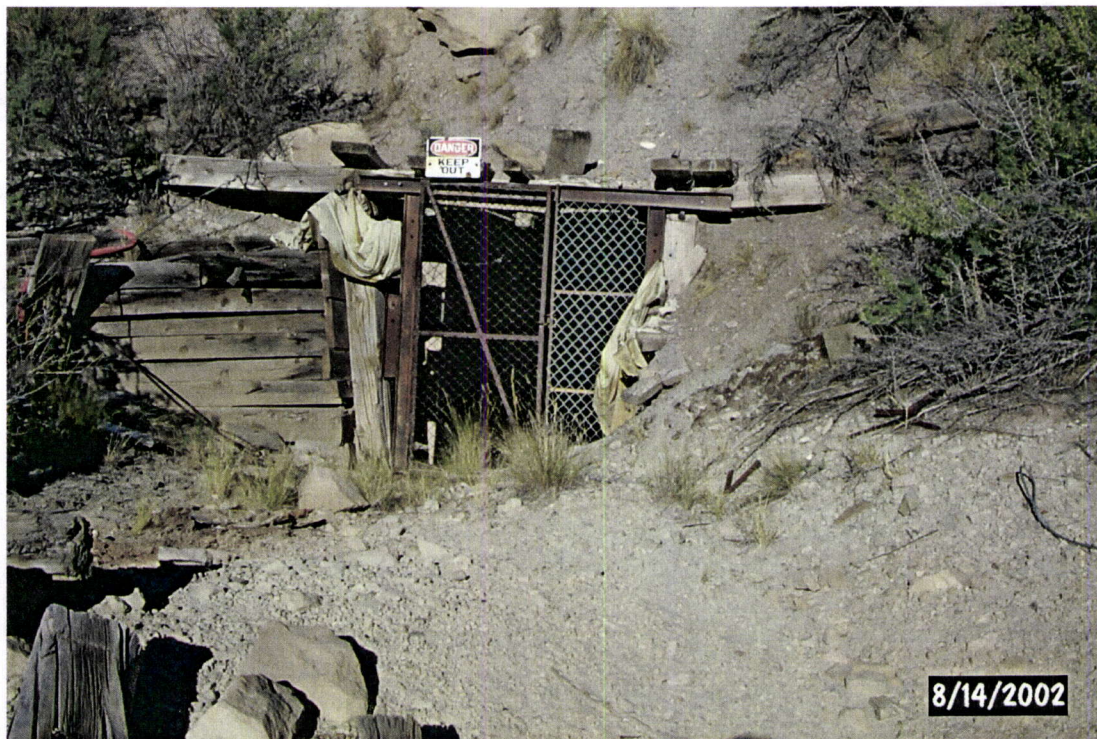
Photo 5. Columbus Portal.

Since 1975, the Columbus Mine has only been used for ventilation, and there is a letter in the file from the Division dated August 6, 1985, stating that the operator's only responsibility at this site is to seal the portal. Until the portal is permanently sealed, it needs to be temporarily secured to prevent entry by the public. I was told in a telephone conversation on September 10, 2002, with Terry Wetz from International Uranium and in another phone call with Jim Butt, a contractor working for International Uranium, on September 11, 2002, that this had been done. Mr. Butt said the material used to backfill the portal was mounded in an attempt to keep water from piping into the portal.

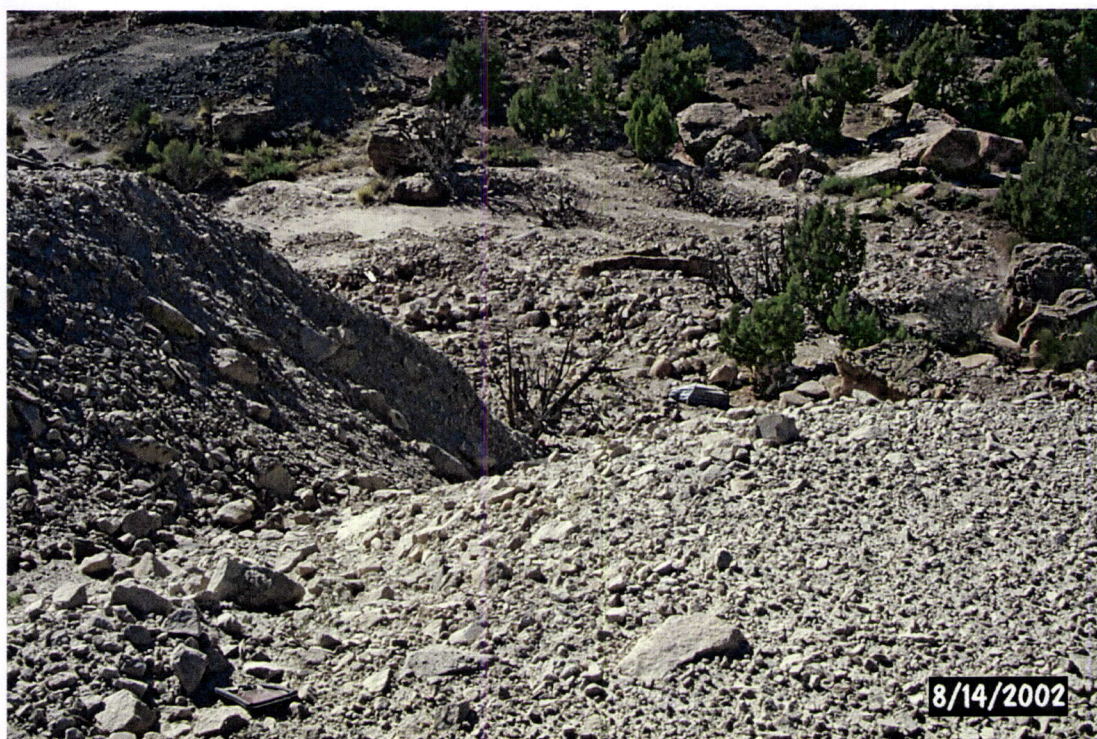
Photo 6. Waste pile at the Columbus Mine. Note the large amount of material in the drainage.

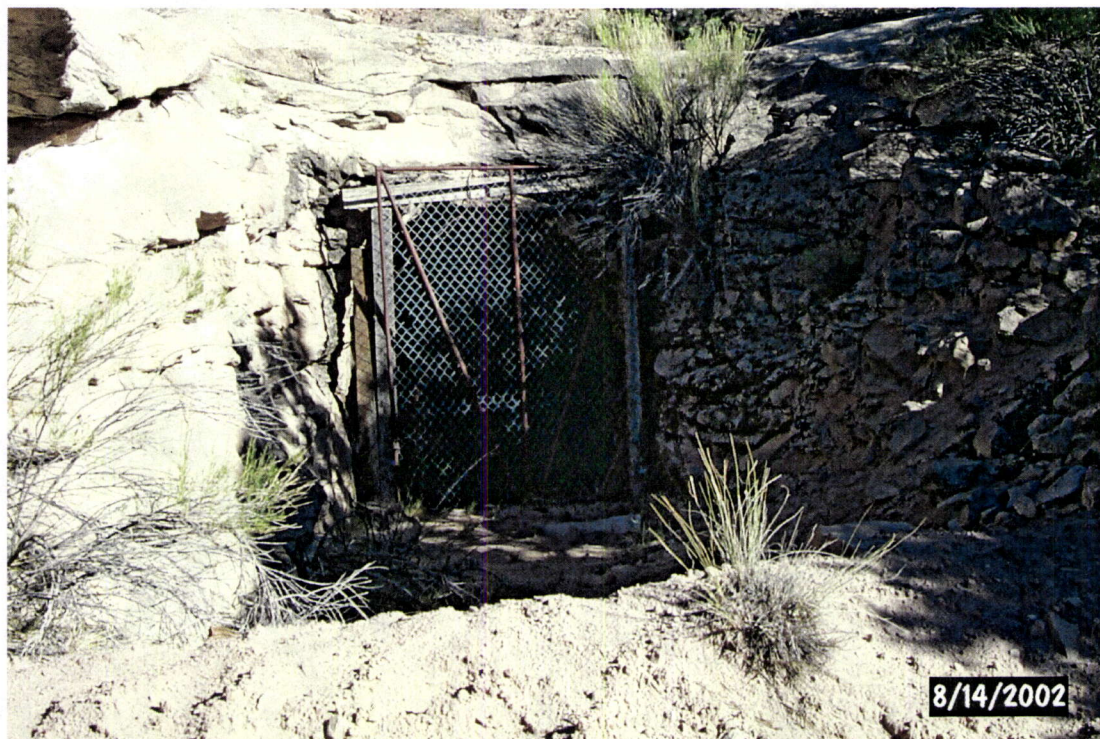
Just before getting to the Humbug Mine, we found another portal and waste pile, and although the workings at this portal are connected with the workings from the Rim, Columbus, and Humbug Mines, the facilities are apparently not associated with International Uranium. This portal is not secured (Photo 7), and the waste pile is, like the pile at Columbus, constructed over the drainage and eroding badly.

I am not sure who is responsible for the portal near the Humbug Mine. Terry Wetz of International Uranium indicated it may have been worked by Jim Butt and that it may have been called the Sunshine Mine, but Mr. Butt said he did not operate in this mine. Ted McDougall of the BLM is not familiar with the Sunshine Mine and has no record of it. If the mine was worked before 1980, he would not have any record. Mr. Wetz indicated International Uranium might be willing to backfill the portal when they have equipment on site, but he is reluctant to do this if another operator might still want to use the site. However, since the site is on BLM land and the BLM has no record of it, it is probably abandoned. The next time International Uranium has equipment in the area, they could consider

Photo 7. Portal at site near the Humbug Mine.

backfilling this portal.

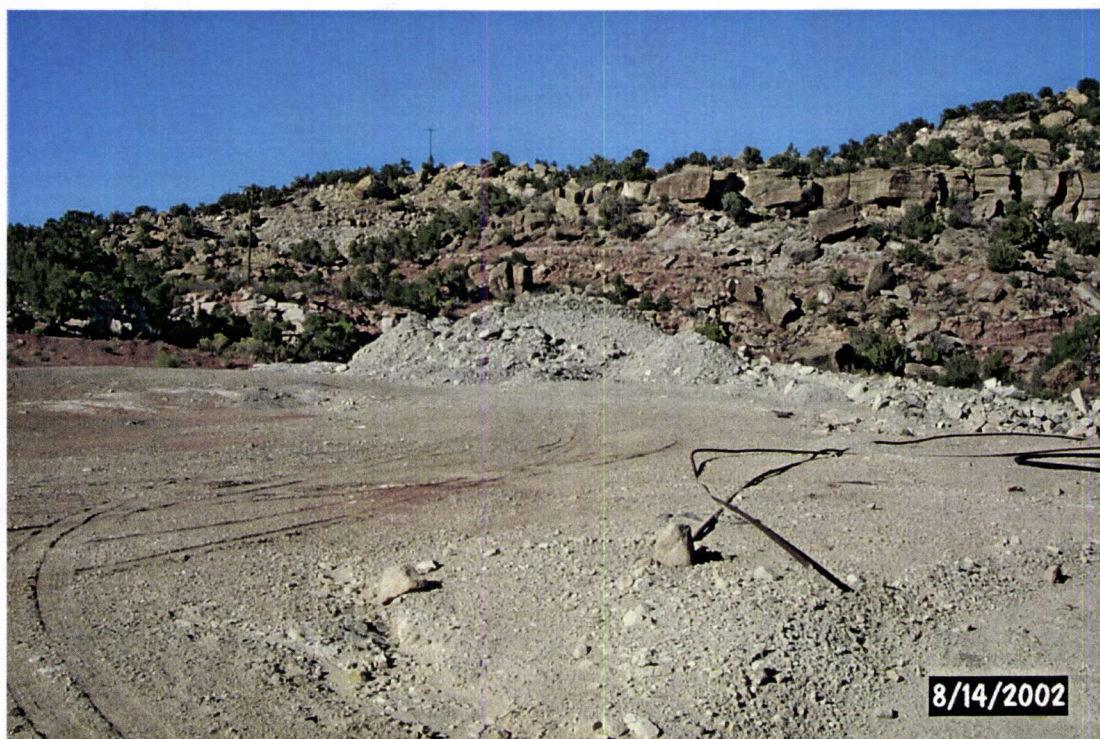
Some work was done at the Humbug Mine in about 1998 or 1999, but most of the site was not reaffected. We found some piles of what appeared to be low grade ore mostly north and above the portal (Photo 8).

Photo 8. Low grade ore or waste at the Humbug Mine.

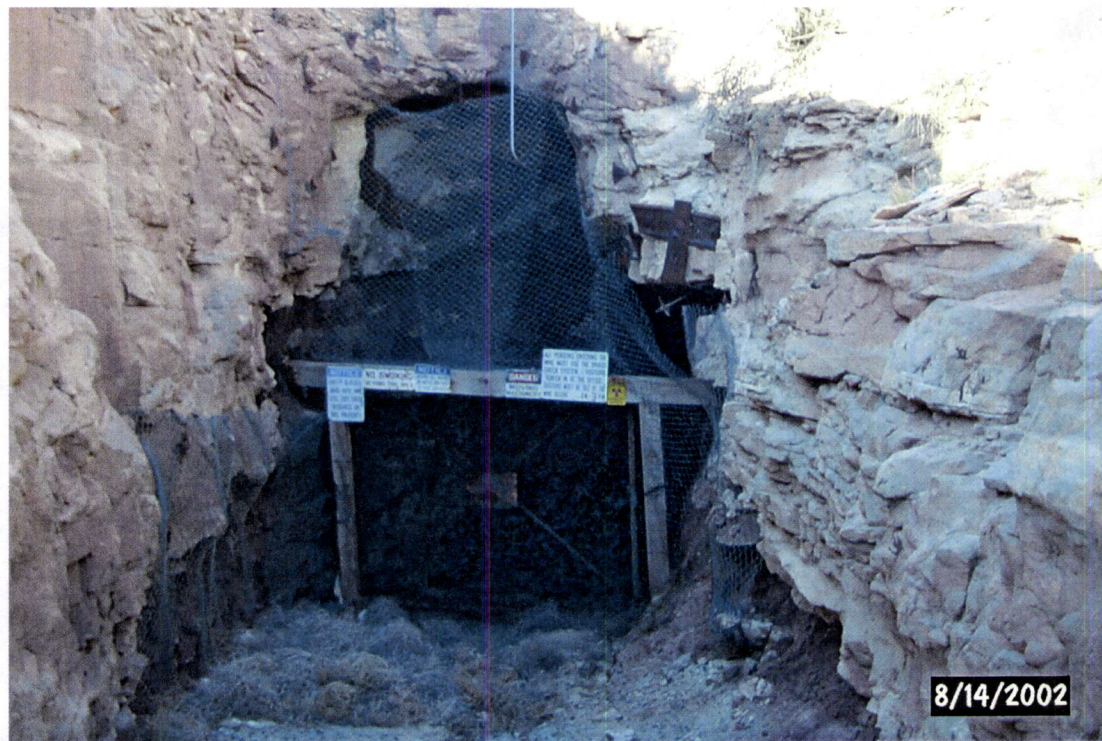
There is a decline cut into the sandstone leading to the portal (Photo 9). The gate over the portal was not secured.

There is a berm on the edge of the waste pile, and it has been breached in one location with waste eroding into the drainage below. Much of the drainage from the mine area would flow into the decline and the portal.

Photo 9. Humbug Mine Portal.

According to Mr. Butt and Mr. Wetz, the Humbug Mine portal has now been backfilled with ore that was pulled out of the mine in about 1997-1999. Mr. Butt said he left a depression about 6-7 feet deep in the decline and that drainage from above the portal is directed into this depression. I understand he also repaired the berm on the outside edge of the waste disposal area.
